Technical Report EL-98-15  
November 1998

# **Feasibility Study for Evaluating Redistribution of Juvenile Salmon in the McNary Bypass Channel Using Behavioral Technologies: 1996**

Prepared for U.S. Army Engineer District, Walla Walla

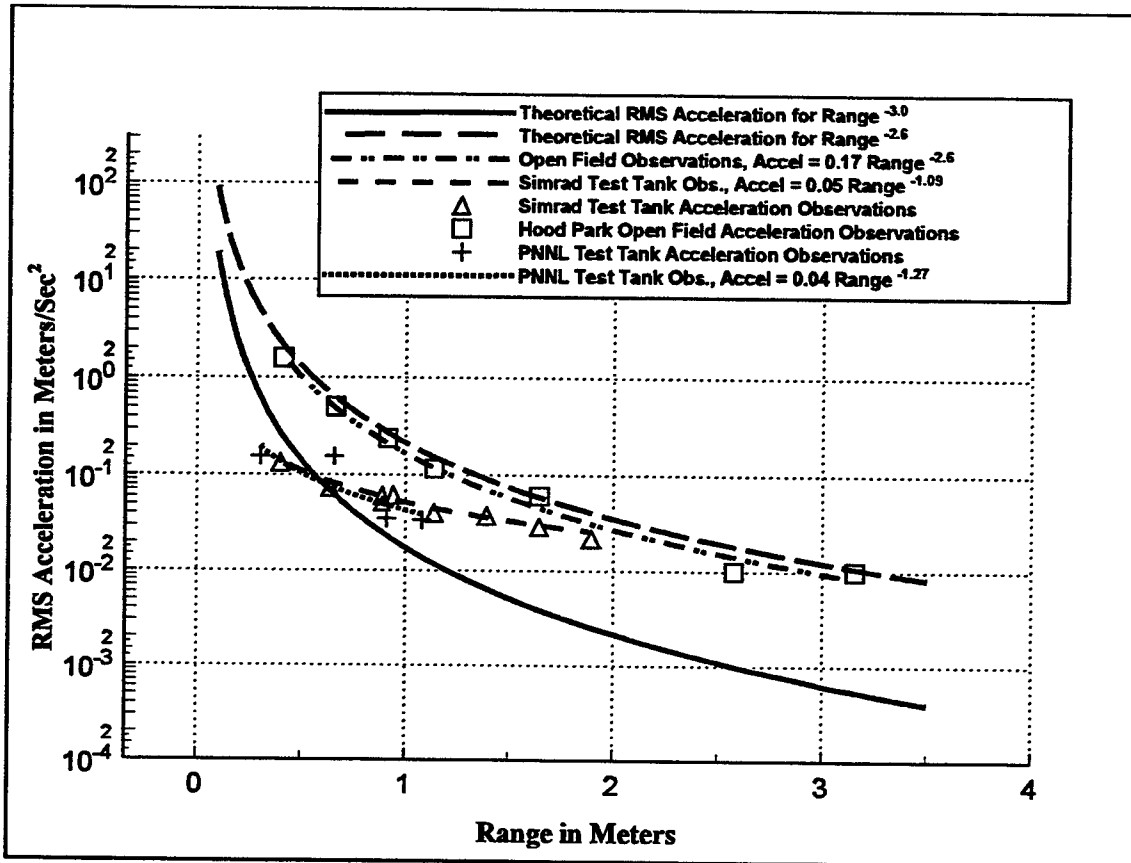
Figure 1. Comparison of tank, open field and theoretical RMS acceleration values as a function of distance from the infrasound source (from Carlson and Campana 1996)

Results of two other infrasound field characterization studies using the same infrasound source and triaxial accelerometer measurement device were compared with accelerations measured in the NPPL test tank. One set of sound field characterization measurements was made at the Simrad Production Facility, Seattle, WA, in a 3 m x 3 m x 3 m test tank. Another set of measurements was made under open field conditions in the Snake River at Hood Park, WA (Carlson and Campana 1996). Results of all three studies, as well as estimates of expected water particle acceleration based on local flow theory presented by Kalmijn (1988), are presented in Figure 1. The comparison reveals the observations of water particle acceleration in the two test tanks (PNPL and Simrad) were very similar to each other, below those observed under open field conditions, but higher than expected from theory. The open field observations showed water particle acceleration values considerably above those expected from theory with a decay constant of 2.6 in contrast to the theoretical decay constant of 3.0. The tank data sets showed the smallest rate of decrease in water particle acceleration with a decay constant of approximately 1.0. The trends in the test tank data indicated that while water particle acceleration in the tank was below that at the same range under free field conditions, at longer ranges it was likely that tank water particle acceleration would approach and perhaps exceed that for the free field. The slower decay under conditions in the tank is likely due to the nearness of the boundaries in the tank and resulting

Acceleration values taken from other applications with the same infrasound device and triaxial accelerometer as those used in this study, as well as estimates of expected water particle acceleration based on local flow theory, were compared to measurement results obtained in this study. The comparison revealed that the results from the two test tanks were very similar to each other, below those observed under open field conditions, but higher than expected from theory.

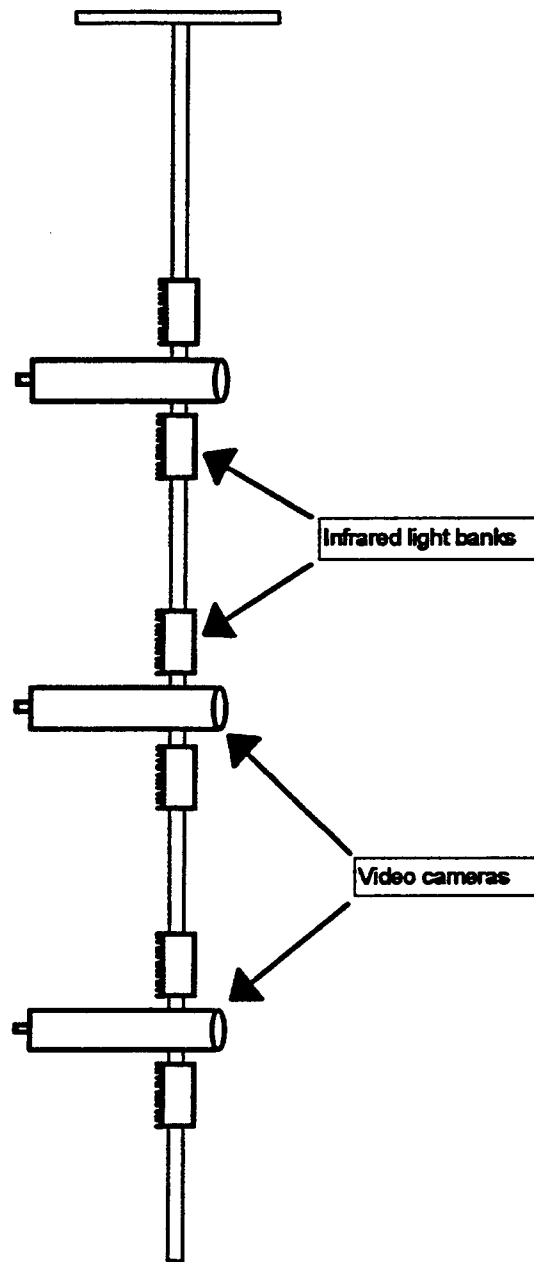
Figure 4. Pole-mounted cameras and infrared light banks used for video evaluations of McNary juvenile bypass in June, 1996. Each camera's field of view was illuminated with 2 infrared light banks.

On June 25, 1996, we deployed pole-mounted cameras and lights (Figure 4) in the transition zone of the bypass channel between the side- and floor-dewatering areas.

Based on May results of ambient and back-lighting schemes and time lapse sampling rates as discussed below, we employed fore-lighting and real time sampling rates for all three cameras during the summer video evaluation efforts. Images of fish passage were recorded from 6:40 p.m. to 9:40 p.m. and 9:55 p.m. to 12:55 a.m. All cameras were

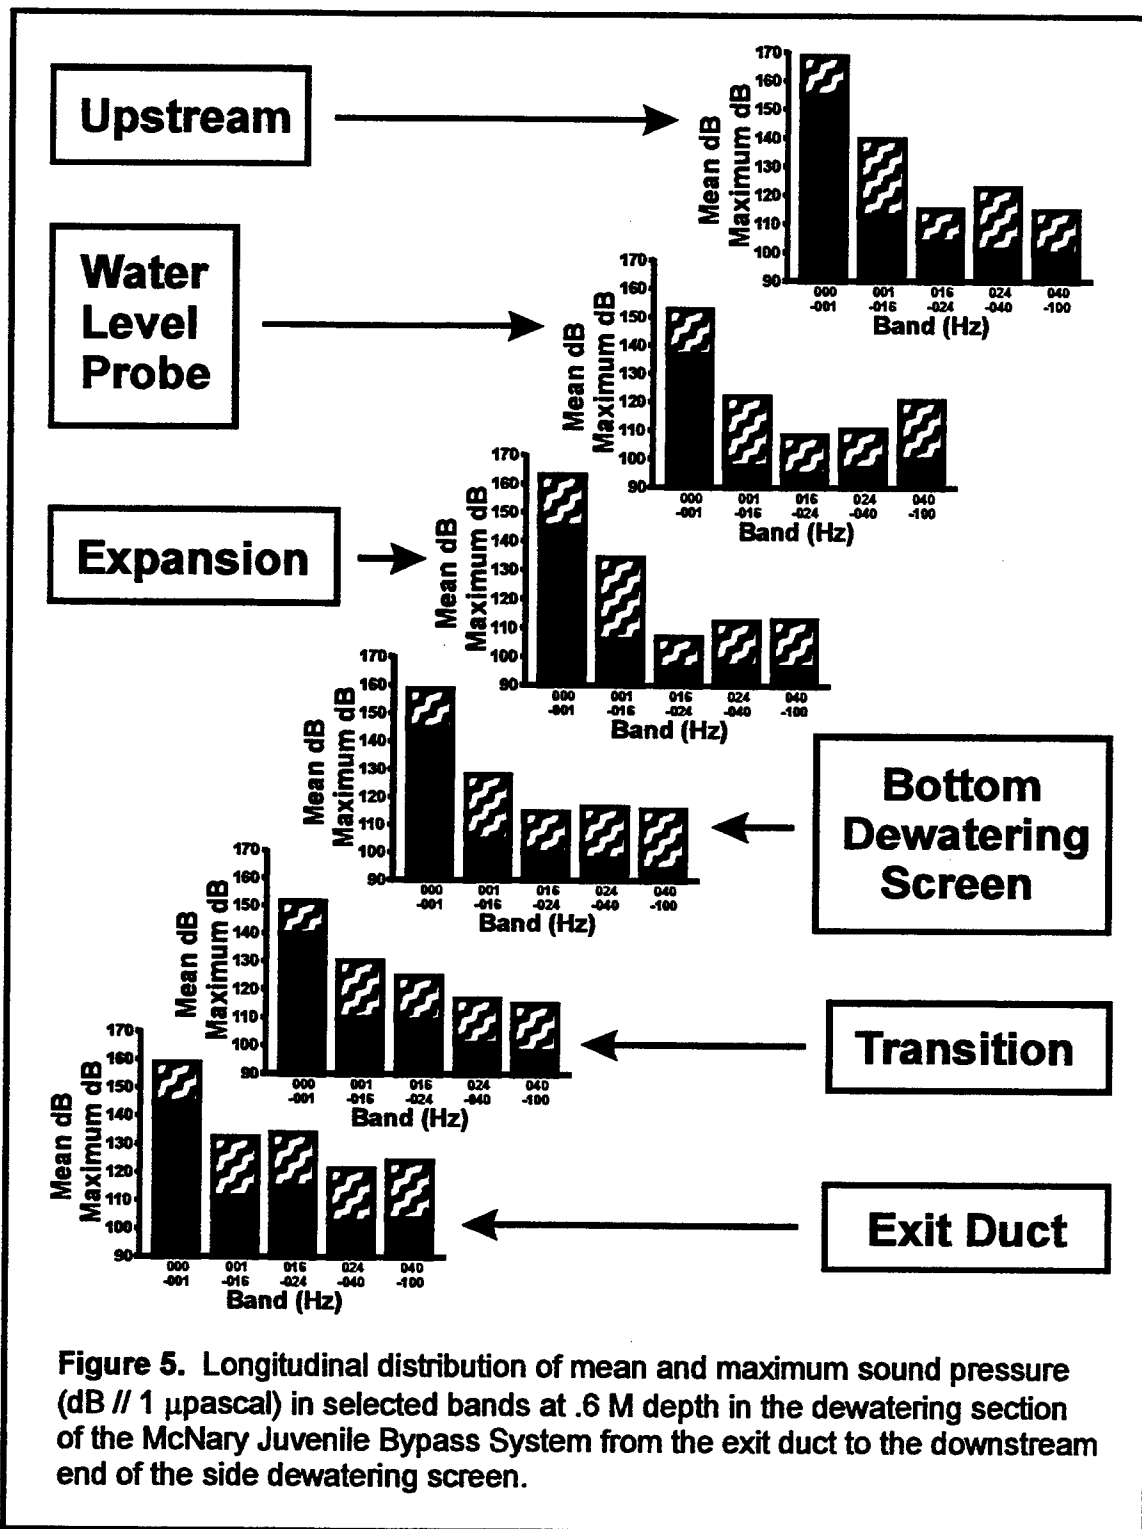
**Figure 5.** Longitudinal distribution of mean and maximum sound pressure (dB // 1  $\mu$ pascal) in selected bands at .6 M depth in the dewatering section of the McNary Juvenile Bypass System from the exit duct to the downstream end of the side dewatering screen.

All stations measured with the MSFS showed the presence of very high sound pressure levels in the 0.125 to 1 Hz range. A number of readings were obtained having pressure levels greater than 165 dB // 1  $\mu$ pa (Figure 5) with a maximum reading of 172 dB // 1  $\mu$ pa. No pattern in the distribution of readings was noted. Results from the accelerometer confirmed the presence of a substantial vibration of the channel lining at this frequency. Given the pervasive nature of the sound, the high sound pressure levels obtained, and other observations made at the site, we conclude that the 0.5 Hz signal is probably not entirely due to a propagated sound wave but also has a major hydrodynamic local flow and or bulk flow component. We observed flows surging through the small adjustable side gates at the most downstream end of the sluiceway and suspect that flows within the channel are hydraulically unstable. Unlike most situations in which the vibration of the hydraulic structure provides the source of underwater sound, the turbulence may be exciting the structure to vibrate.

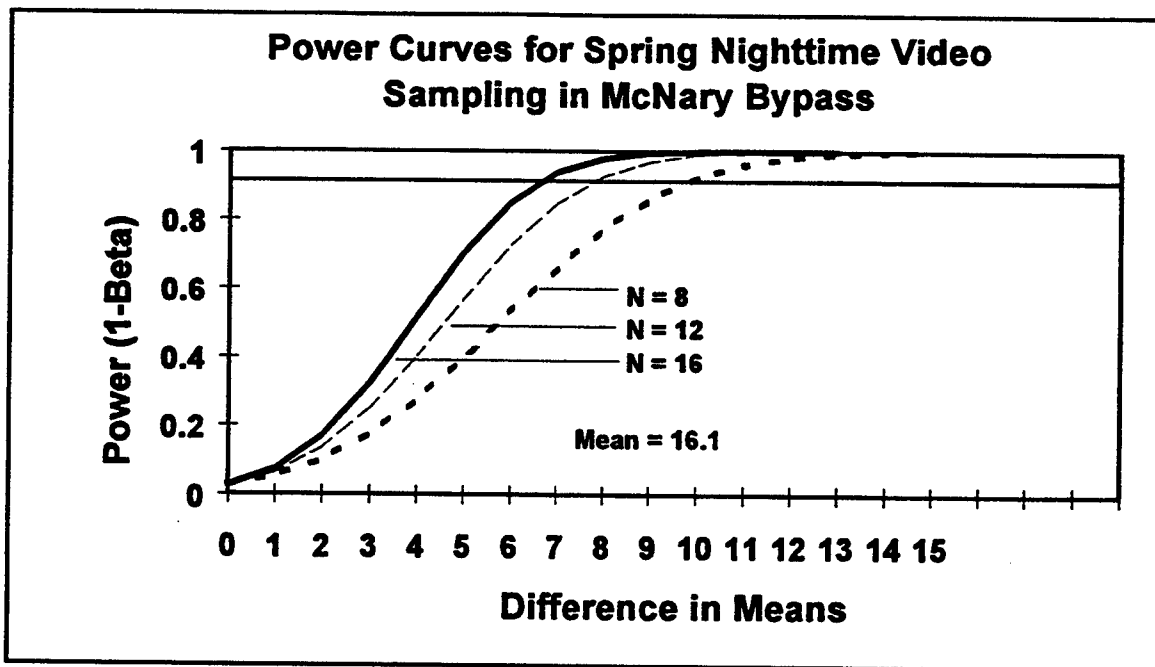
Figure 7. Power of the test curves for varying sample sizes using video sampling in McNary bypass channel. Sample size represents paired hours of on-off treatments. Curves are used to determine required sample size given desired level of mean difference detection. Sample size of  $n=12$  will allow for 90% power to reject the null hypothesis of no difference given a 50% difference in the means.
